# Investigation Report

### Clean Water Branch

ID #: PA0991D

Facility: Waste Management Hawaii/CCH

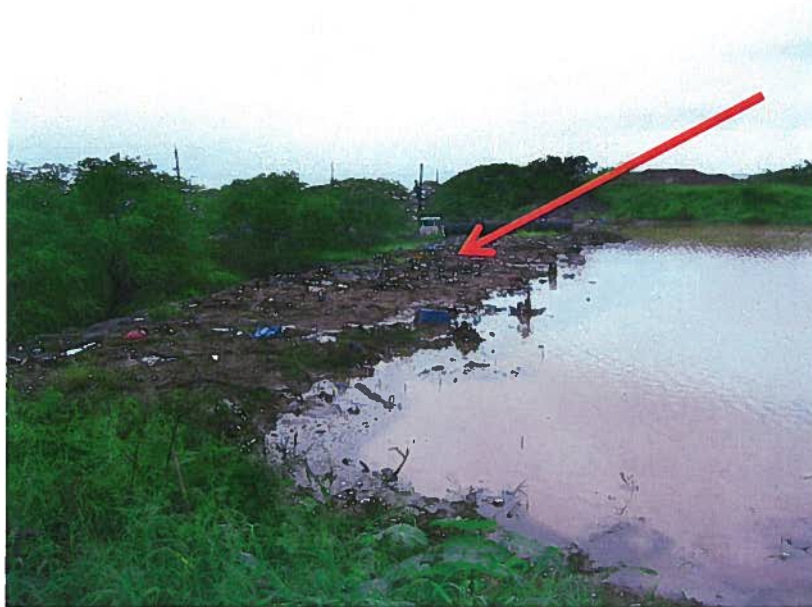
Photograph # 1

- 2) ☐ At approximately 12:15 pm, representatives from the DOH-CWB and EPA, met DOH-SHWB representatives at the Landfill. Upon arrival, DOH-CWB and DOH-SHWB representatives observed solid waste accumulated on the Landfill's detention basin berm (Photograph 1) as well as in the area between the detention basin and Farrington Highway (Photograph 2). At approximately 12:20 pm, a heavy flow of highly turbid water was observed in Landfill's concrete lined channel (Photograph 3). The source of the heavy flow observed was unknown at the time of inspection.

Description: View of the Landfill's detention basin berm (Red Arrow). Debris and solid waste was observed on the berm of the detention basin.

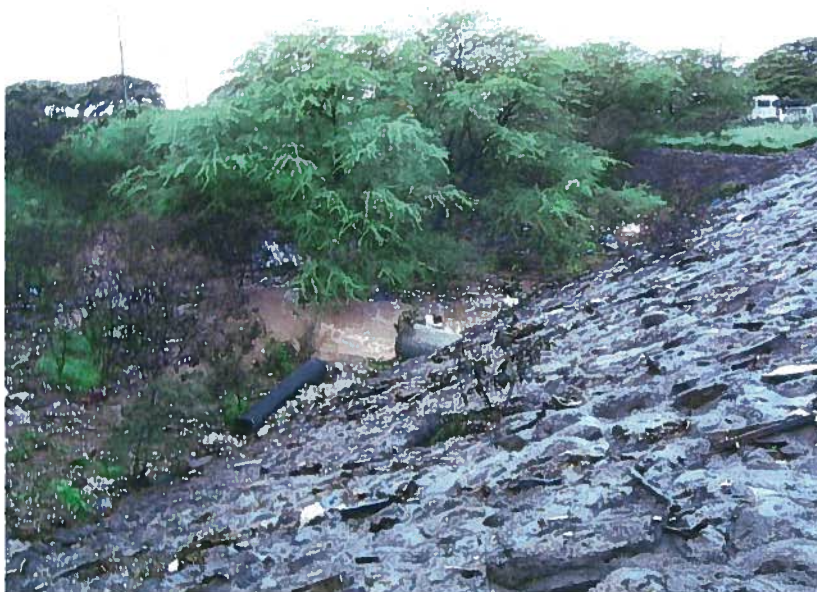
Photograph # 2

Description: View of the detention basin between Farrington Highway and the detention basin's berm. A significant amount of solid waste was observed in the area between the Landfill's detention basin and Farrington Highway. Solid waste was observed on the top and side of the detention basin's berm which indicated that the berm was overtopped and released solid waste to the Landfill's drainage system.

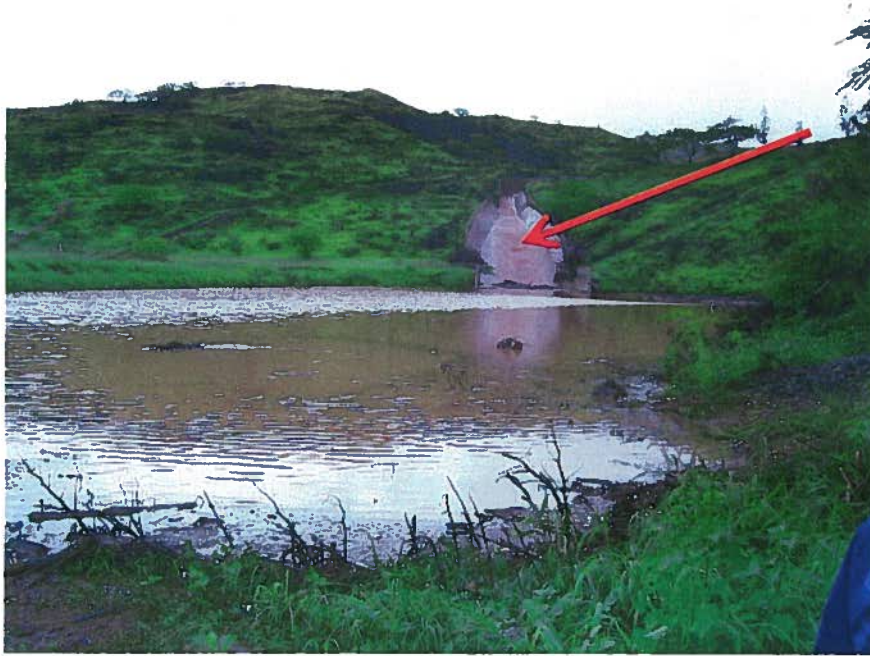
Photograph # 3

Description: View of an unknown flow (Red Arrow) into the Landfill's detention basin. A heavy flow into the detention basin was occurring at the time of inspection.

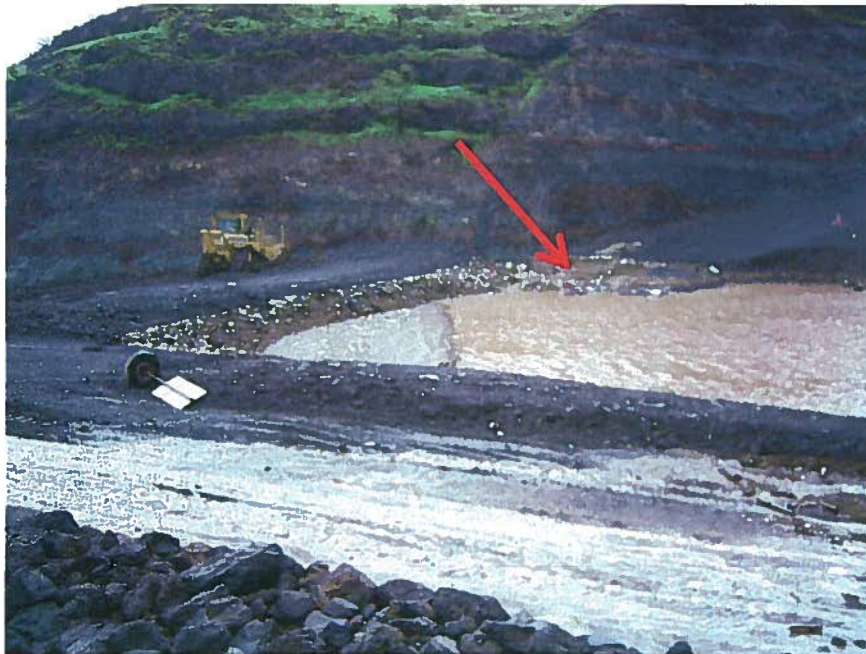
Photograph # 4

- 4) ☐ At the time of inspection, the E6 cell was completely flooded with storm water. The berm located on the south side of the E6 cell (Photograph 4) was being augmented at the time of inspection. J. Frey stated that Goodfellow Bros. construction crews were adding material to the berm to dam the storm water that had flooded the E6 cell (Photograph 5). A small accumulation of solid waste was observed on the south side of the E6 cell. The lack of floatables and sludge contrasted observations made during previous inspections conducted after flooding of the E6 cell. During the January 4, 2011 inspection, a larger layer of sludge-like material and floatables was observed in the E6 cell.

5) Based on the high water mark observed on the berm/dam, the water level in the E6 cell had come within approximately one (1) foot of topping the berm at its highest level (Photograph 4). At the time of inspection, the water level in the E6 cell appeared to have decreased approximately two (2) feet below the high water line. It was unclear how the water level in the E6 cell could have dropped so rapidly.

6) M. Kurano questioned J. Frey about the status of the "Hobas" pipe opening that was located on the southwest side of the E6 cell. J. Frey stated that the opening of the "Hobas" pipe was closed to prevent the discharge of any of the impounded water in the E6 cell. J. Frey stated that there had been no discharges from the E6 cell since December 23, 2010, when the Landfill was notified that discharges from the E6 cell were violations of Hawaii Water Pollution rules and regulations. J. Frey stated that nothing was discharged from the E6 cell and that he had inspected the shoreline area and had seen no solid waste.

Description: View of the south side of the E6 cell. An earthen berm was acting as a dam and containing the contaminated storm water that inundated the E6 cell. The "Hobas" pipe opening (Red Arrow) is located on the southwest side of the E6 cell.

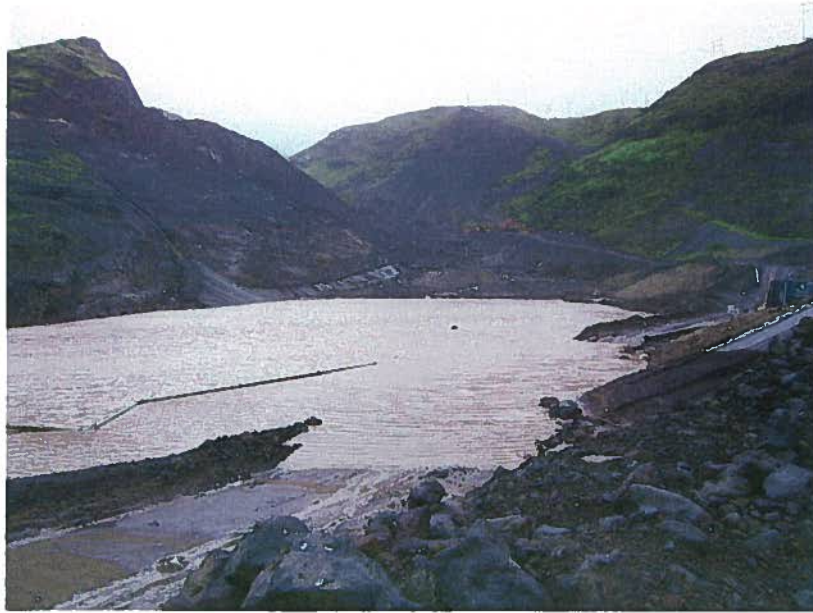
Photograph # 5

Description: View of the E6 cell facing north. The entire E6 cell was flooded at the time of inspection.

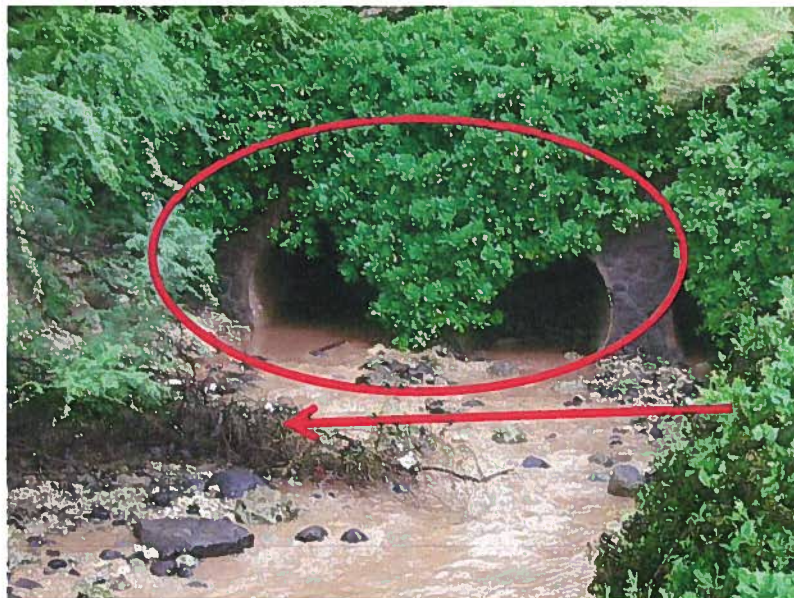
Photograph # 6

7) After inspecting the Landfill's E6 cell, the Landfill's shoreline outfall (Photograph 6) and receiving water (Photograph 7) was inspected. A significant amount of solid waste material was observed in the area (Photograph 8) immediately north of the outfall. The solid waste observed in the area north of the outfall appeared to be recently deposited. Various solid wastes such as plastic bottles were observed. The plastic bottles were clear and did not appear to have been weathered for an extended period of time. Within the solid waste observed immediately north of the Landfill's outfall, medical waste such as syringes, needles (Photograph 9), and medicine bottles were observed. Solid waste was also observed in the tree branch located within the flow path of the Landfill's outfall (Photograph 10). The solid waste deposited in the tree branch included syringes and various other solid wastes. During the inspection of the Landfill's outfall area, representatives from the Ko Olina resort arrived at the Landfill's outfall.

Description: View of the Landfill's shoreline outfall (Red Circle) at the time of inspection. Turbid discharges were observed at the time of inspection. Solid waste was observed in the tree branch directly in front of the Landfill's outfall (Red Arrow).

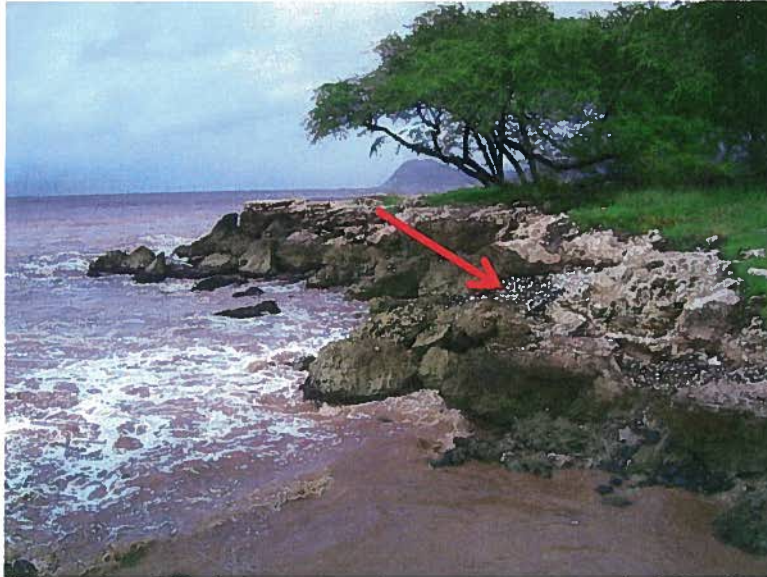
Photograph # 7

Description: View of the receiving water in front of the Landfill's outfall. Solid waste (Red Arrow) accumulated in the area immediately north of the outfall.

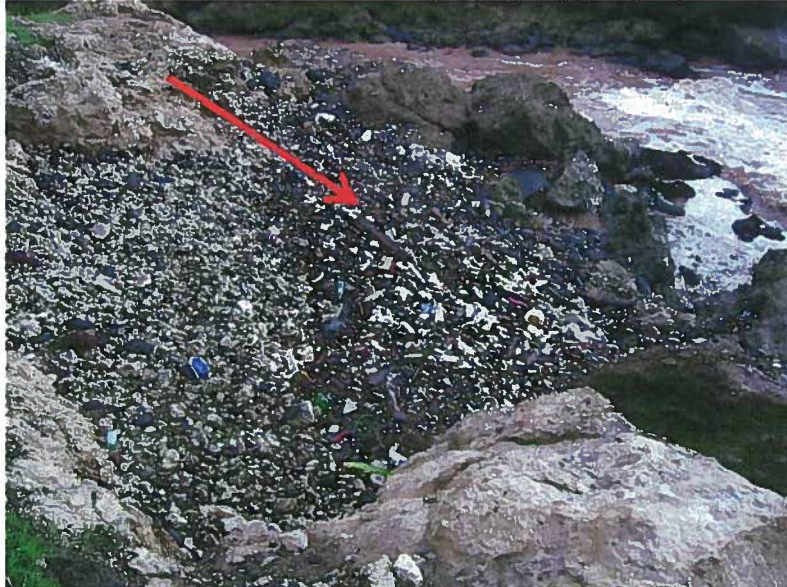
Photograph # 8

Description: View of the accumulated solid waste (Red Arrow) in the area immediately north of the outfall. The solid waste appeared to be from a land based source. The waste included plastic bottles, various solid waste, and medical waste.

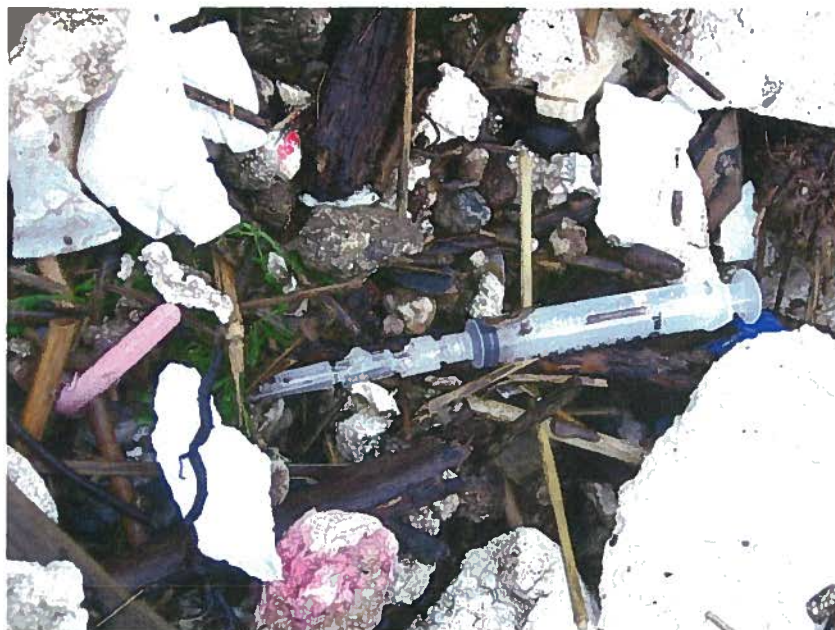
Photograph # 9

Description: View of a syringe and hypodermic needle observed in the solid waste which accumulated in the area immediately north of the Landfill's outfall.

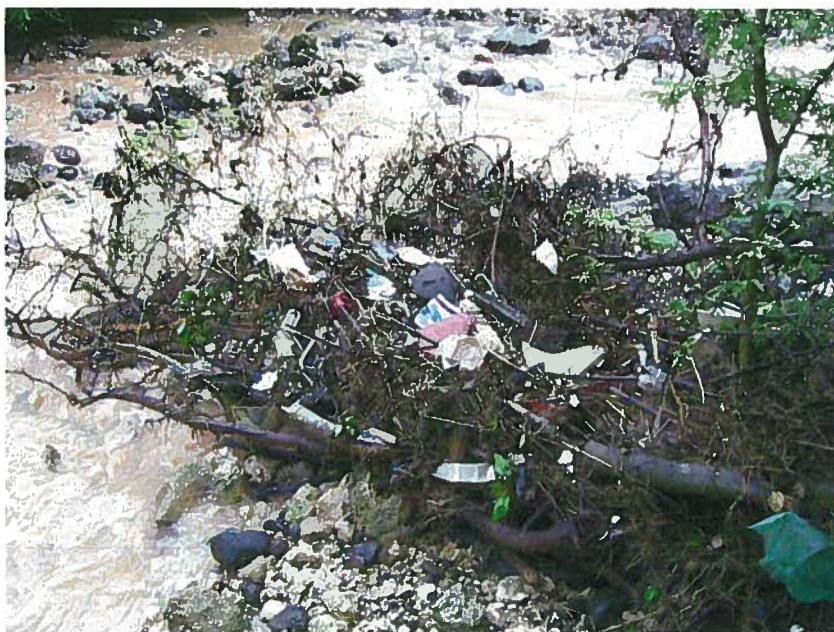
Photograph # 10

Description: View of the solid waste accumulated in the tree branch in front of the Landfill's outfall. Same tree branch as pictured in Photograph 6. Solid waste included medical waste such as syringes with hypodermic needles still attached.

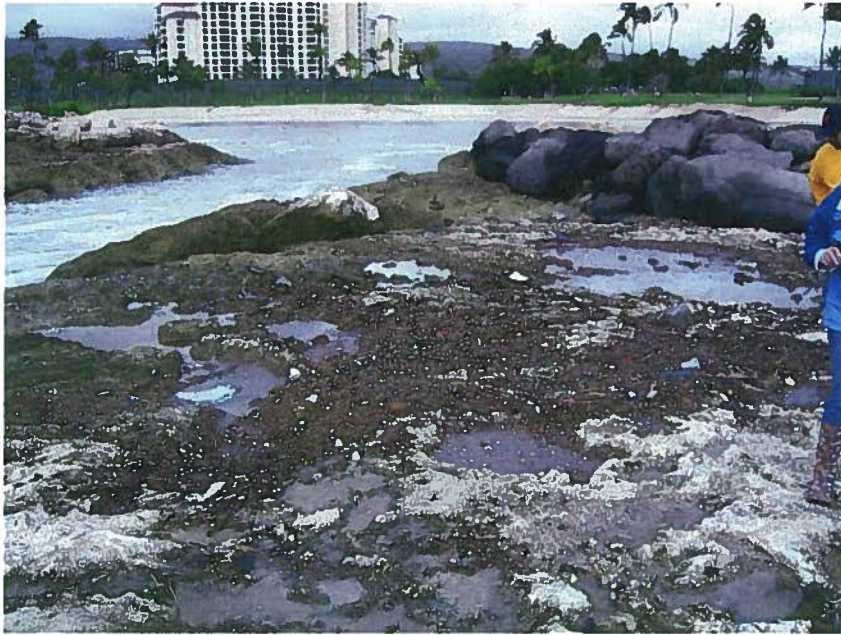
Photograph # 11

8) Eddie Belluomini, Operations Manager for Ko Olina Operations, stated that on the morning of January 13, 2011, Ko Olina personnel found a significant amount of debris and medical waste in Ko Olina's lagoons and the area immediately south of Lagoon 4 (Photograph 11). E. Belluomini stated that at approximately 7:00 am on January 13, 2011, Ko Olina staff conducted a routine shore patrol and reported finding medical waste. E. Belluomini stated that Ko Olina staff started raking the lagoon areas in response to finding the medical waste and that the lagoons had been closed. E. Belluomini stated that finding medical waste at Ko Olina had not happened before during his tenure at Ko Olina. E. Belluomini provided the DOH-CWB with two (2) gallon sized bags of medical waste that was collected at or around the Ko Olina shoreline on January 13, 2011.

Description: View of solid waste and debris which had accumulated immediately south of the Ko Olina Lagoon 4.

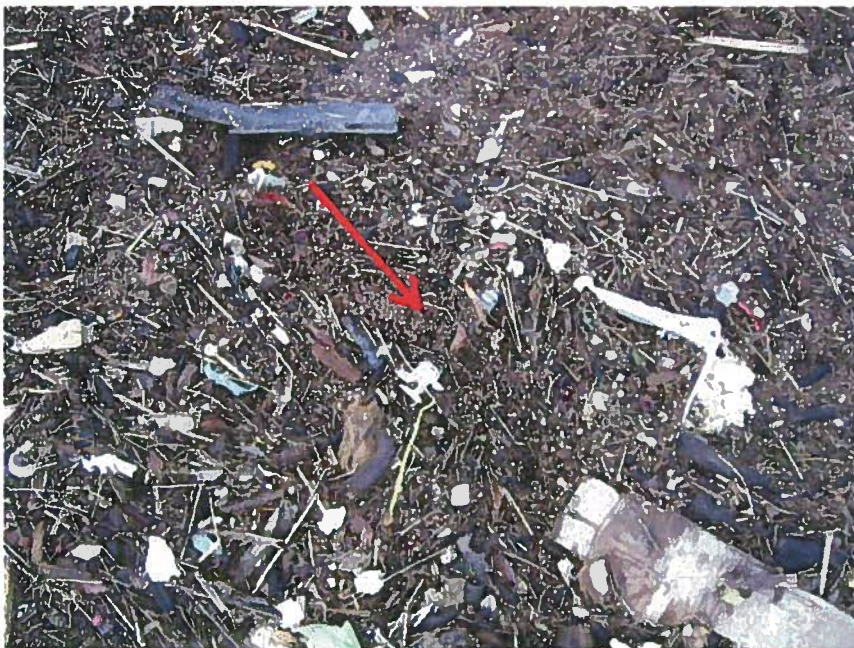
Photograph # 12

9) DOH and EPA observed significant amounts of debris and medical waste in and around the south side of Lagoon 4 (Photograph 12) at the time of inspection.

Description: View of the solid waste accumulated immediately south of the Ko Olina Lagoon 4. The solid waste included general debris as well as medical waste (Red Arrow).

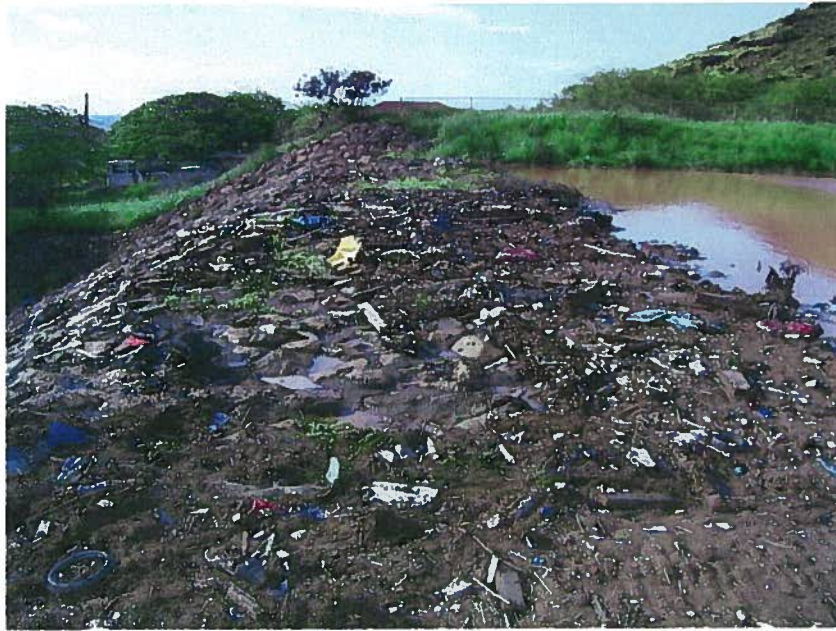
Photograph # 13

10) After observing medical waste and other solid waste in the shoreline area around the Landfill's outfall as well as in and near Ko Olina's Lagoon 4, EPA and DOH-CWB representatives went back to the Landfill. Upon arrival at the Landfill, the Landfill's detention basin berm (Photograph 13) was closely inspected. The solid waste deposited on the detention basin's berm included bags labeled "biohazard" (Photograph 14), used intravenous fluids bags (Photograph 15), hypodermic needles (Photograph 16) and syringes, bags that appeared to be autoclaved medical waste, various other medical wastes and other assorted solid waste. The solid waste collected in the area between the Landfill's berm and Farrington Highway (Photograph 17) was of similar composition as to what was observed on the berm of the Landfill's detention basin (Photograph 18). A Waste Management Hawaii worker was actively collecting the solid waste on the Landfill's berm. The worker stated that he was finding medical waste throughout the solid waste on the Landfill's berm.

Description: View of solid waste which had accumulated on the Landfill's detention basin berm on January 13, 2011. The solid waste included general debris and medical waste.

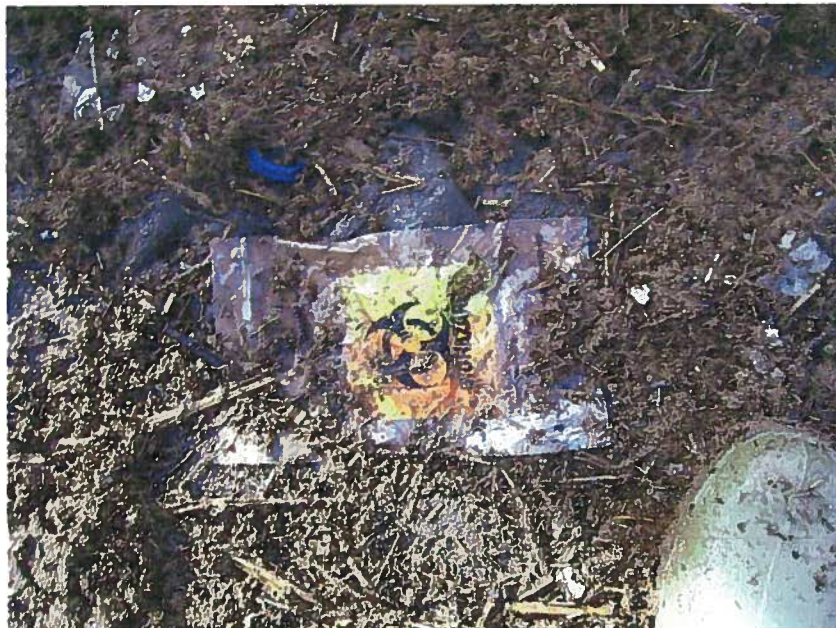
Photograph # 14

Description: View a specimen bag labeled "Biohazard" which was observed on the Landfill's detention basin berm. There were many similar bags of medical waste on the berm at the time of inspection.

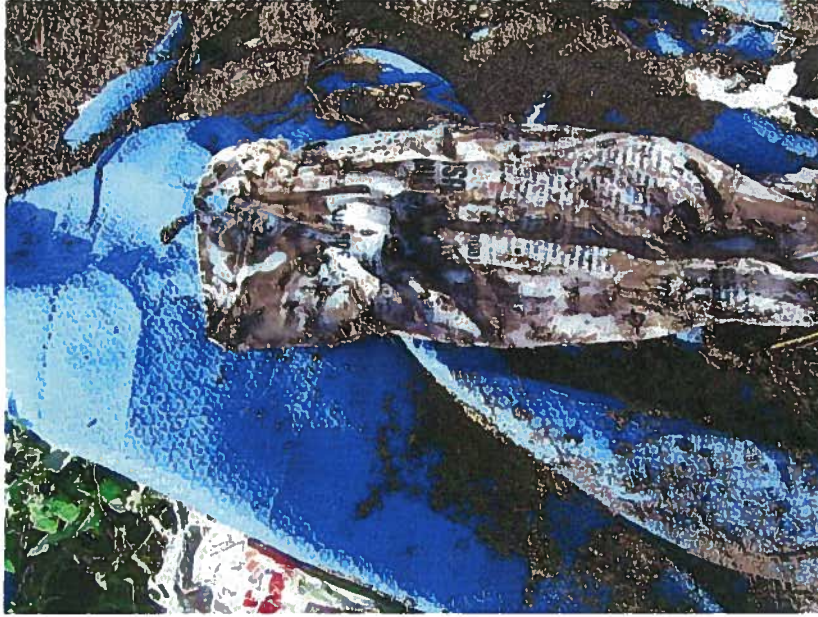
Photograph # 15

Description: View of an IV bag and a other waste observed on the Landfill's detention basin berm.

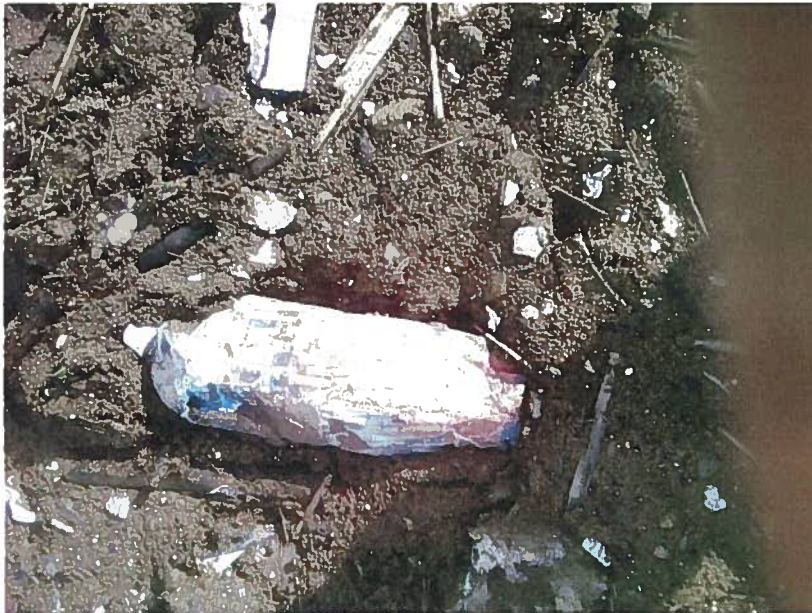
Photograph # 16

Description: View of a bag of syringes and needles. The bag was observed on the Landfill's detention basin berm.

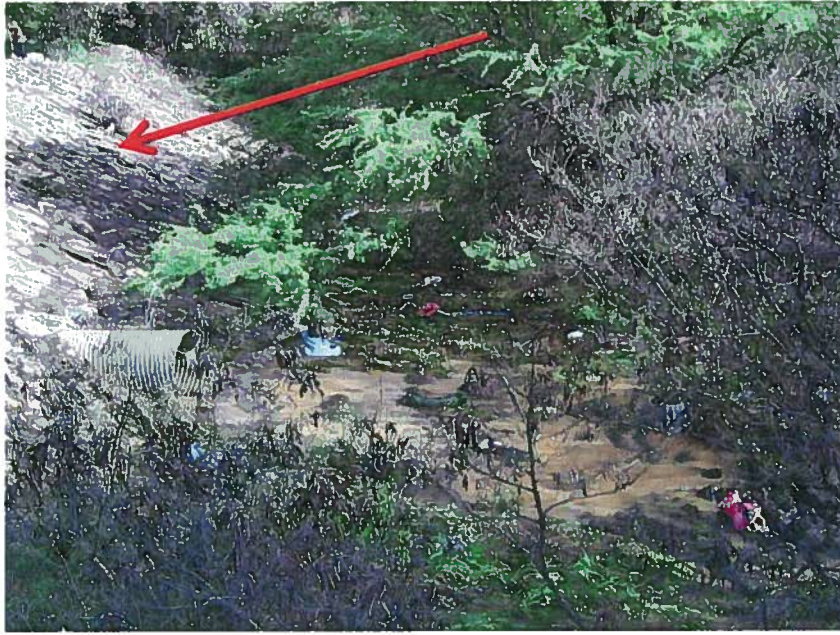
Photograph # 17

Description: View of solid waste, including medical waste, discharged from the Landfill's detention basin. The solid waste pictured was located in the area between the Landfill's detention basin berm (Red Arrow) and Farrington Highway.

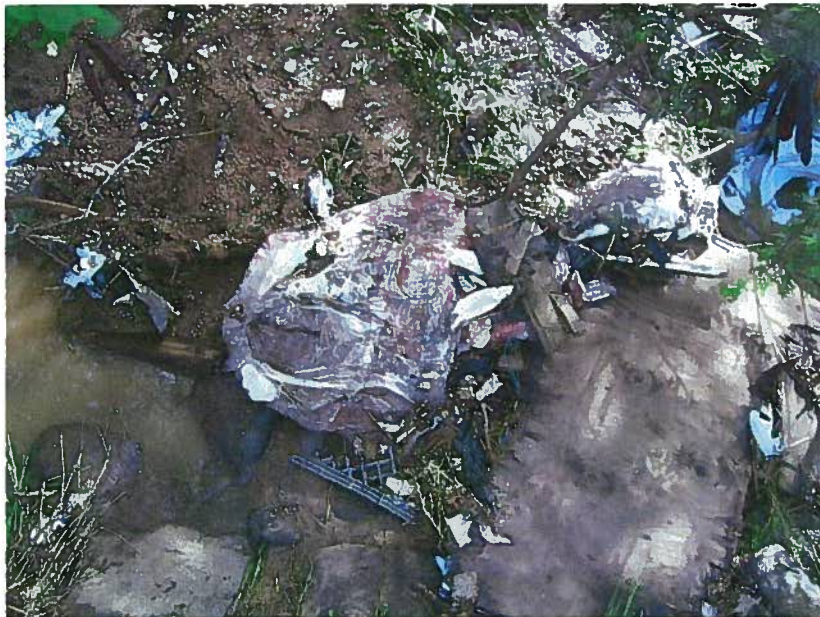
Photograph # 18

Description: View of a ruptured bag of what appeared to be medical waste observed between the Landfill's detention basin and Farrington Highway. The ruptured bag appeared to be one of the red colored medical waste bags that appeared to be autoclaved prior to disposal at the Landfill.

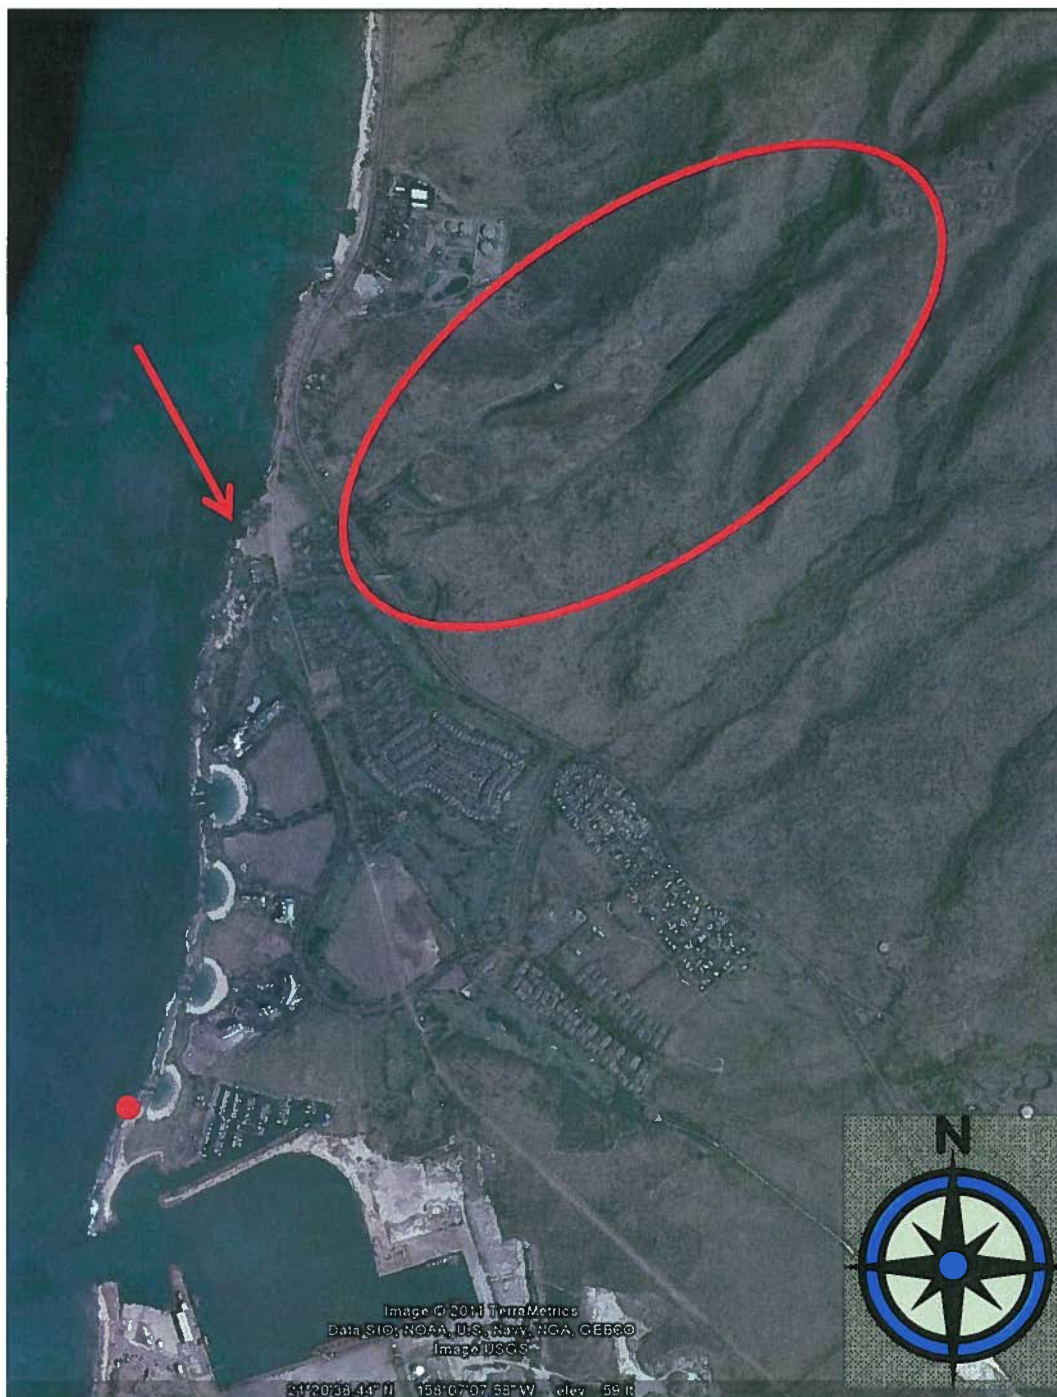
Image 1

Description: View of the Landfill (Red Oval). Discharges from the Landfill enter into State waters at a shoreline outfall (Red Arrow) located southwest of the Landfill. Solid waste, including medical waste, was observed in the area adjacent to the outfall as well as throughout Ko Olina's four (4) lagoons. A heavy concentration of solid waste (Red Dot) was observed outside of Ko Olina's Lagoon 4.
